<b>DRESSING COMPONENTS NO. 01</b>		CS09-19-C-001-E	A
		Made by: pelrom	Date: 15.04.04

## Foldover clasp kit Reference 117ST3000.000 ~ Cousins Part Ref: X18351

### OLD VERSIONS OF FOLDOVER CLASPS SUBSTITUTION SOLUTION

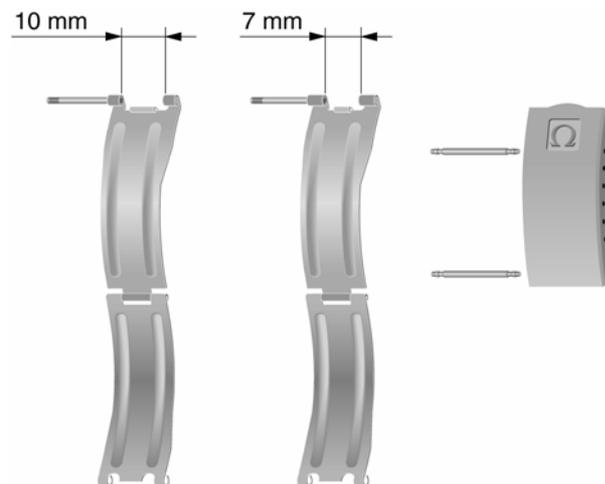
**Figure 1**

Most of these clasps have the same dimensions **except** for the bracelet fixing point at 6 o'clock, which is available in two versions : 7 mm and 10 mm.

Availability of a bracelet kit ref. 117ST3000.000 including :

- 1 clasp with 10 mm fixing
- 1 clasp with 7 mm fixing
- 1 cover, width 17 mm,
- thus allowing the required version to be chosen.

When replacing a clasp, the identification of the bracelet will be lost. Any order for accessories for bracelets with 3000.000 engraved on the clasp must specify the case reference and the number of the end points engraved on each end of the bracelet.

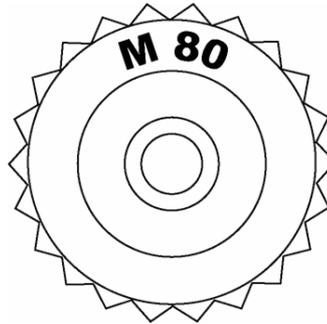
**Figure 1****069 XX 42132**

#### New crown 42132

- BA and BC versions in 18 k gold.
- ST version in steel with new gasket.
- The ST 42107 crown has been replaced by the ST 42132.
- The ED 42107 crown remains available, as an option, for the gold-plated De Ville models.

To avoid any confusion, the thread size of the crown 42132 (0.80) is engraved on the gasket cover ring.

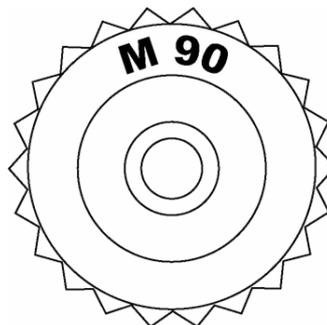
**Figure 2****069 XX 42134**

**CONSTELLATION LINE****New crown 42134**

- BA and BC versions, in 18 k gold with new gasket.
- ST version in steel with new gasket.
- The BA and ST 42082 crowns have been replaced by the 42134 version.
- The LA 42082 crown remains available as an option for the older models.

To avoid any confusion, the thread size of the crown 42134 (0.90) is engraved on the gasket cover ring.

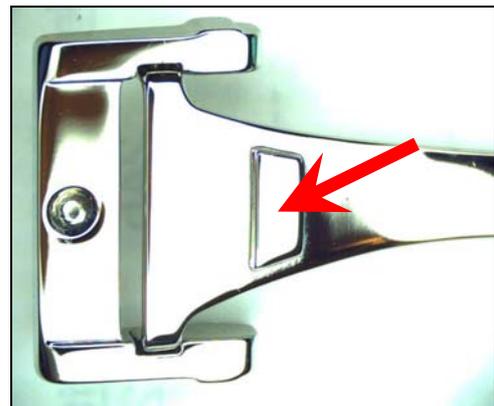
Underneath the upper part of the clasp, there is a trapeze-shaped metal piece (see red arrow right and blue arrow below).

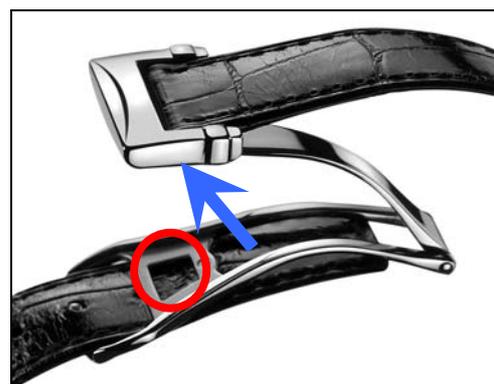
To close properly, the trapeze piece must fit into a trapeze-shaped hole on the lower part of the clasp (see circle right).

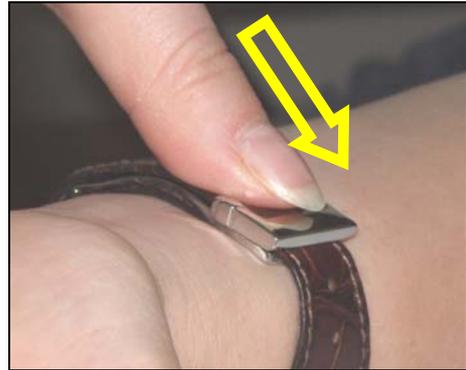
To close correctly, the trapeze part must be pushed into its hole. Thus, the upper part of the clasp must be...

- **Pushed laterally down** as shown on the picture right

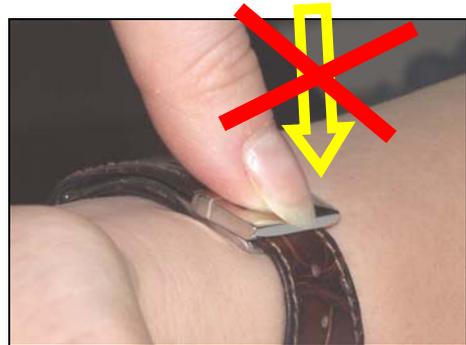
Pushing the superior part of the clasp downwards, as shown on the picture beside, **does not close the clasp, but bends its curved parts.**

After a clasp is bent, it will no longer **close properly.**

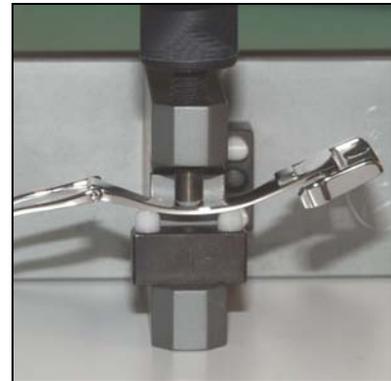
### **Situation 1: The clasp does not close properly**

Correction: The curved upper part of the clasp must be bent further. This can easily be done by hand or with an appropriate tool (as shown right).

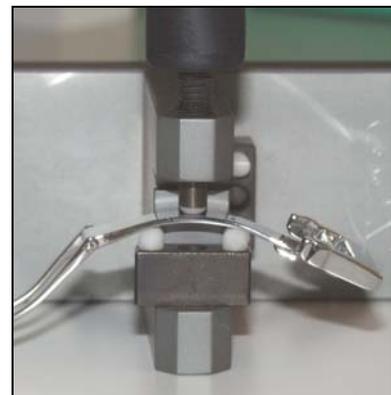
### **Situation 2: The clasp closes too tightly**

Correction: The curved upper part of the clasp must be less bent. This can be done by hand or with an appropriate tool (as shown right).
